ESKIMO VII TEST RESULTS

Robert N. Martha

Naval Civil Engineering Laboratory

ESKIMO VII, seventh in the series of Explosive Safety Knowledge Improve-
ment Operation Tests, was conducted to determine the safety and performance
of Navy box-shaped ammunition storage magazines. The two magazines tested,
the Type A (new design) and Type IIB (old design), were the remaining half-
scale structures from the July 1980 ESKIMO VI test. The Type A magazine was
tested using a foam High Explosive Simulation Technique (HEST) on its roof.
The Type IIB magazine was tested one week later using a small hemispherical
surface charge of 13,616 pounds of TNT. The two interior columns of the
Type A magazine catastrophically collapsed when subjected to a HEST impulse
approximately three times greater than the design impulse. Although the
yield-line pattern and response predicted for the flat-slab structure never
occurred, the roof remained intact while undergoing maximum support rotations
of 16 degrees. These data indicate a high probability of eliminating the

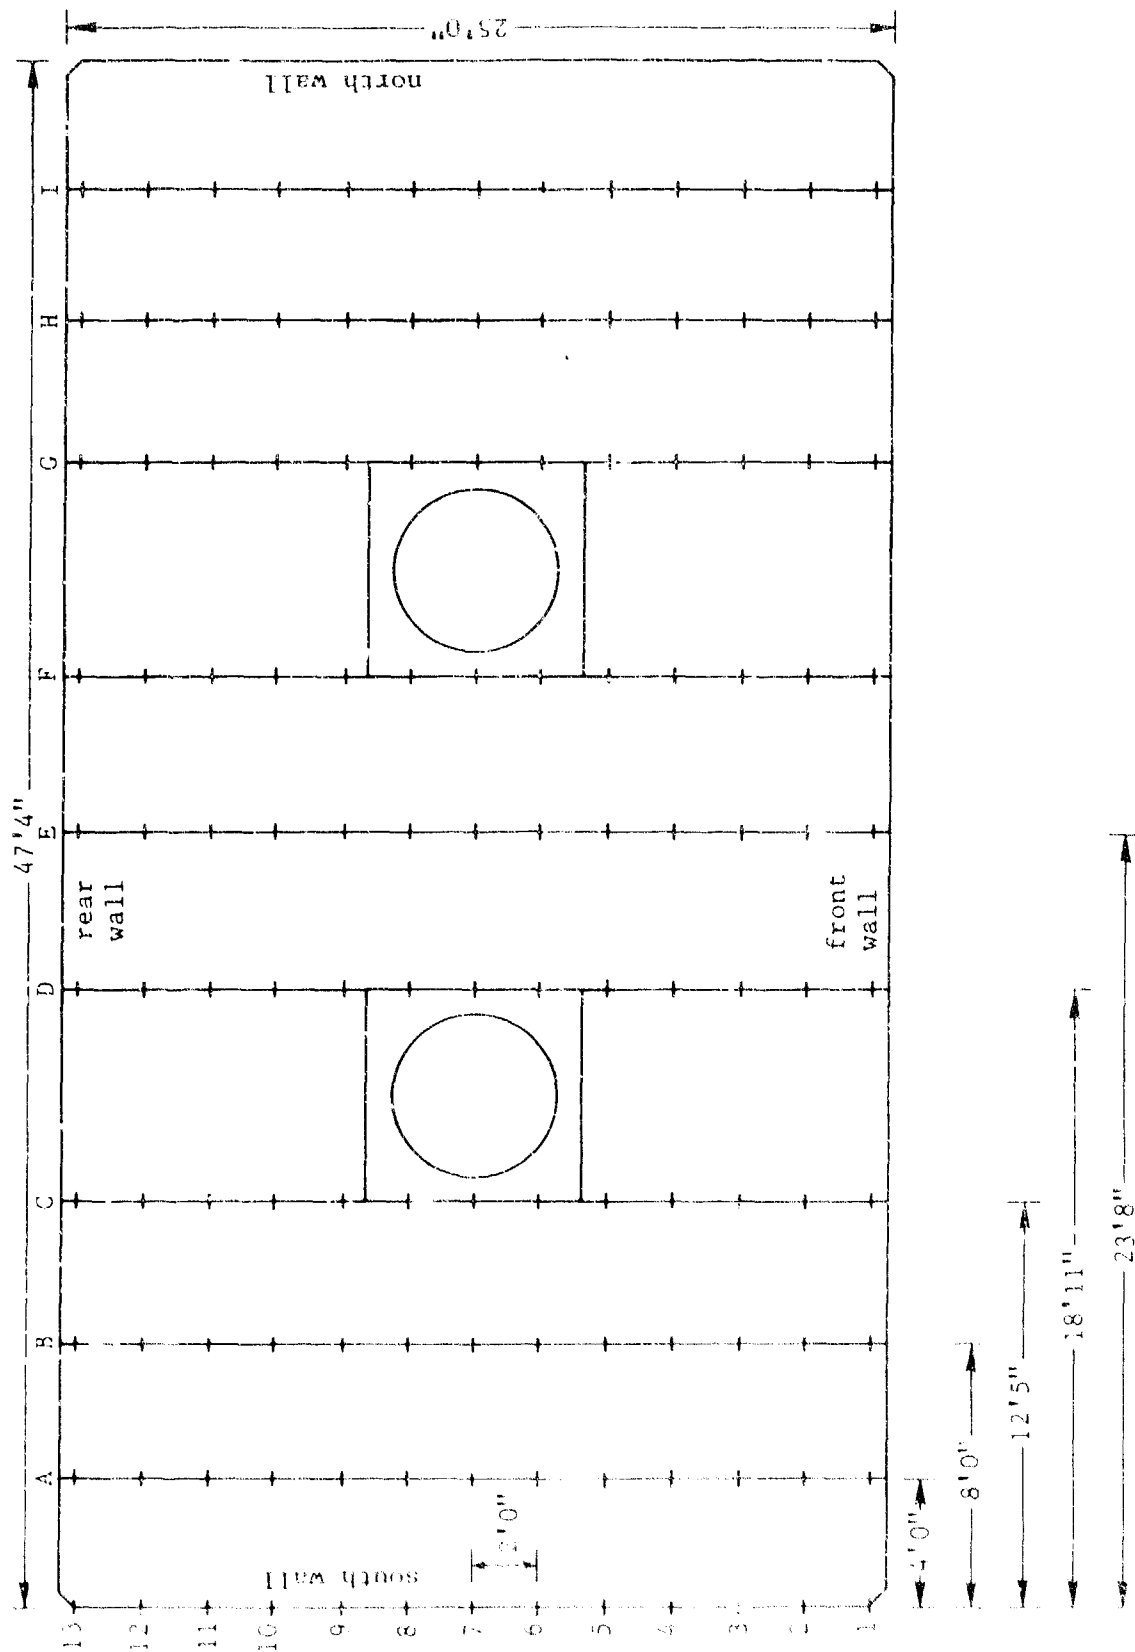
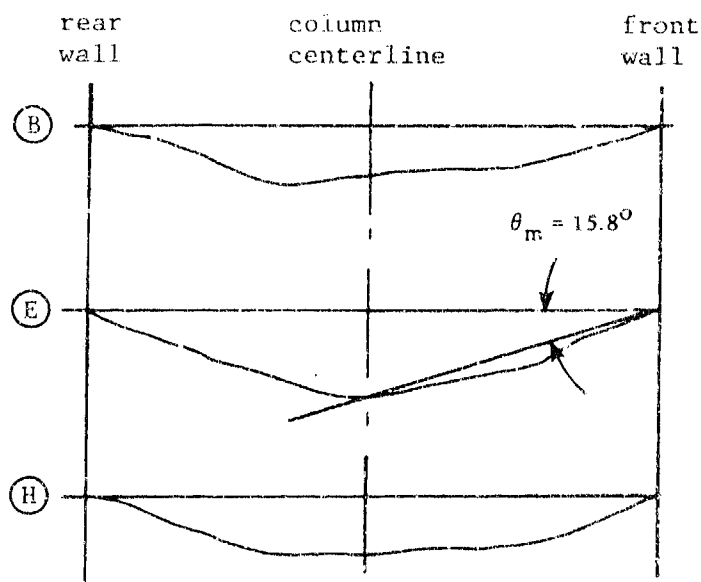
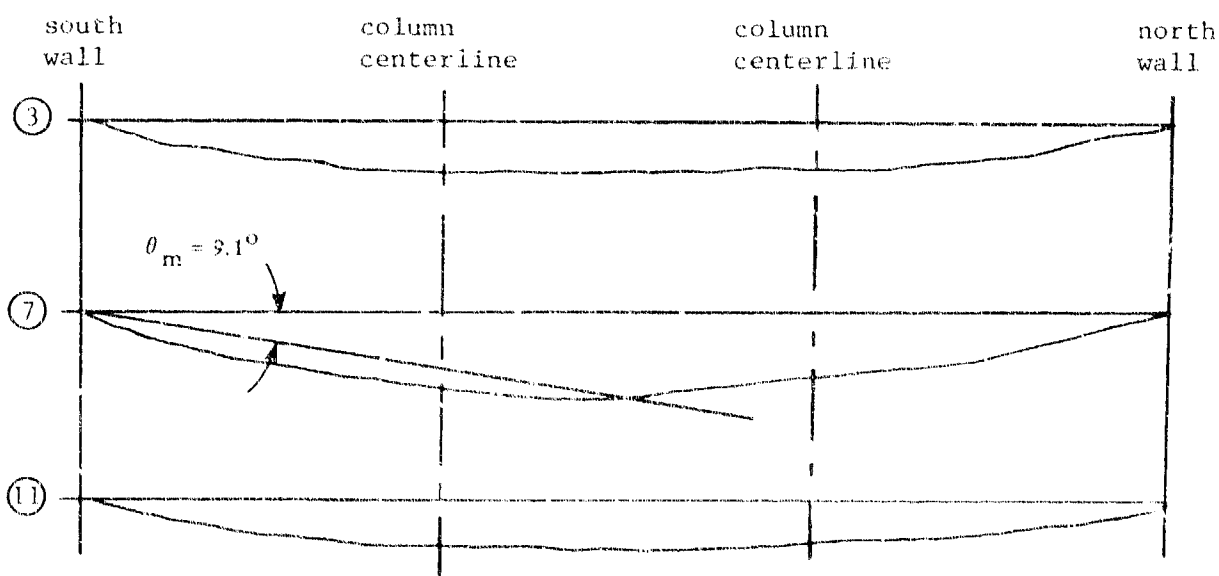
Figure 26. Deflection measurement locations and roof slab profiles for the Type A structure.

vertical and
horizontal scales
for profile

Observed Structural Response. Test A-ROOF took place on 5 September 1985. Figure 23 illustrates the sequence of the foam HEST event. The explosive source was designed to produce a maximum impulse of 2,300 psi-msec on the Type A magazine roof. The average measured impulse of 2,500 psi-msec was only slightly greater than predicted. A post-test view of the magazine interior is shown in Figure 24. Both interior columns catastrophically collapsed, changing the roof configuration from a flat slab to a rectangular two-way slab restrained on four sides. The large dynamic deflections that occurred resulted in the roof acting primarily as a tensile membrane member in the short direction (front to rear). None of the principal steel reinforcing bars were broken or showed signs of necking down. A view of the roof after excavating the left rear quadrant is shown in Figure 25. The permanent deflections of the roof surface measured along nine lines (A through I) are displayed in Figure 26 and listed in Table 5. The permanent center deflection at midspan of the roof was 45.5 inches. The maximum support rotation measured in the short direction along Line E equals 15.8° . The maximum support rotation measured in the long direction along Line 7 equals 9.1° .

^aSee Figure 26 for location of these displacements.

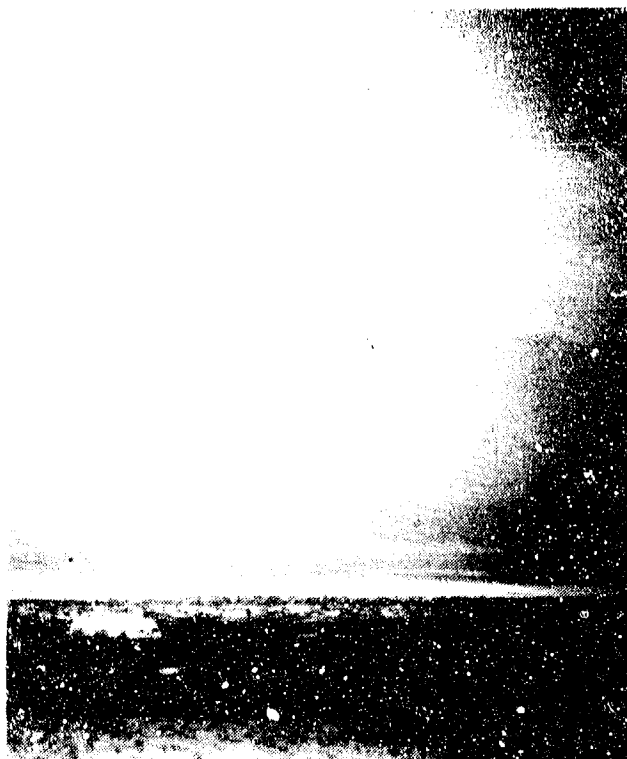
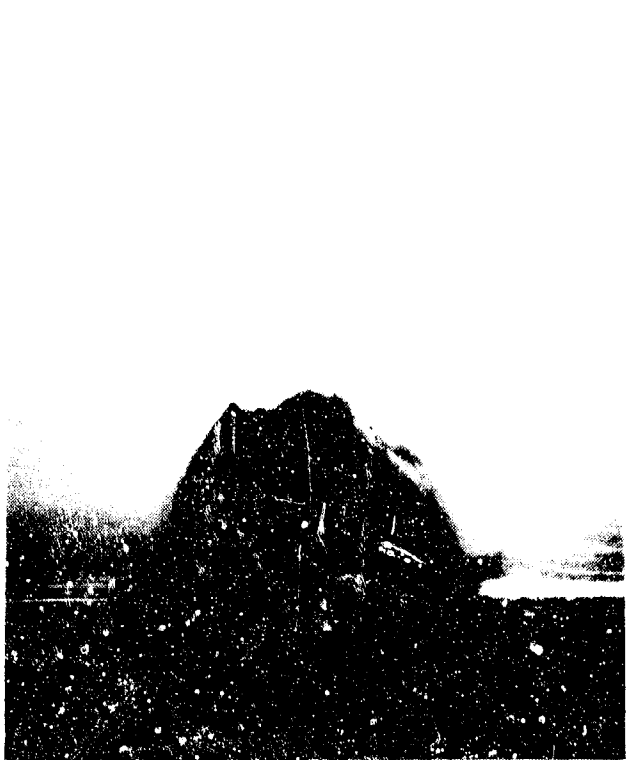
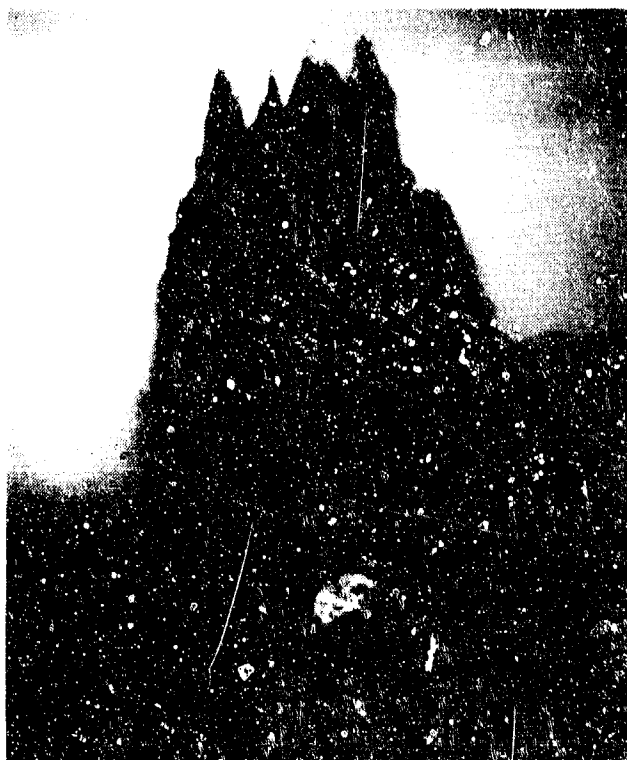
Figure 23 Test A - ROOF detonation sequence.

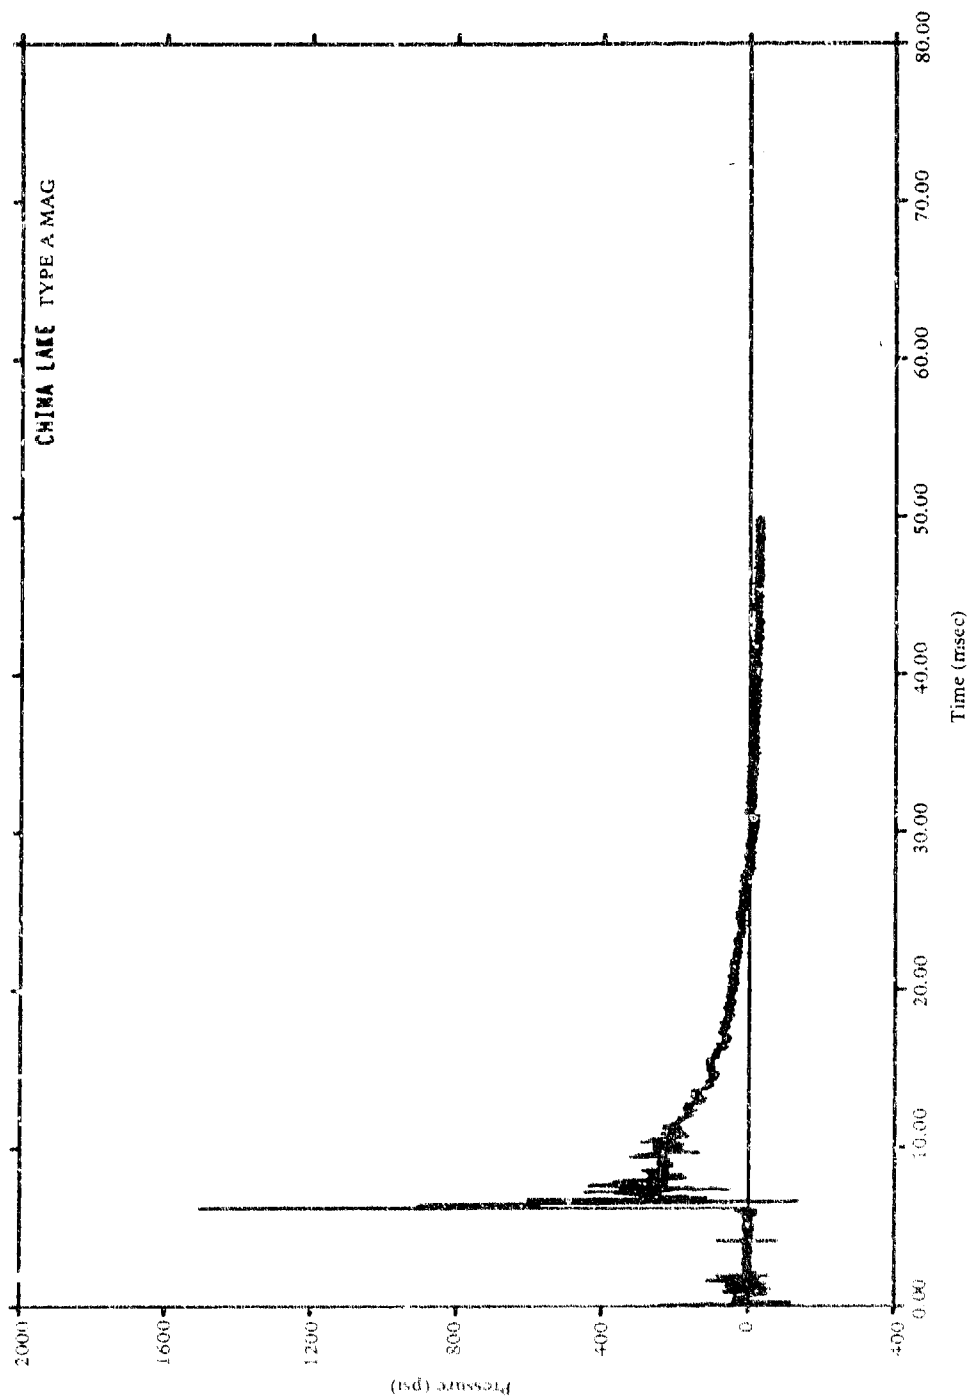
Figure 27. Typical airblast pressure gage output for Test A-ROOF, Gage No. A-D3-BP4.

Response Instrumentation. Data recovery in general was poor. In view of the catastrophic collapse of the interior columns this loss of data was not unexpected. Data from only three of the recovered airblast pressure gages is considered useful. A summary of the airblast data is listed in Table 6 and a representative time history plot is shown in Figure 27. A summary of data derived from velocity gage output is shown in Table 7. Gage No. A-C2-V3 was attached to the column and was lost immediately confirming the sudden early collapse of the columns. All three vertical roof displacement gages functioned satisfactorily until reaching the established 18-inch limit of gage travel.

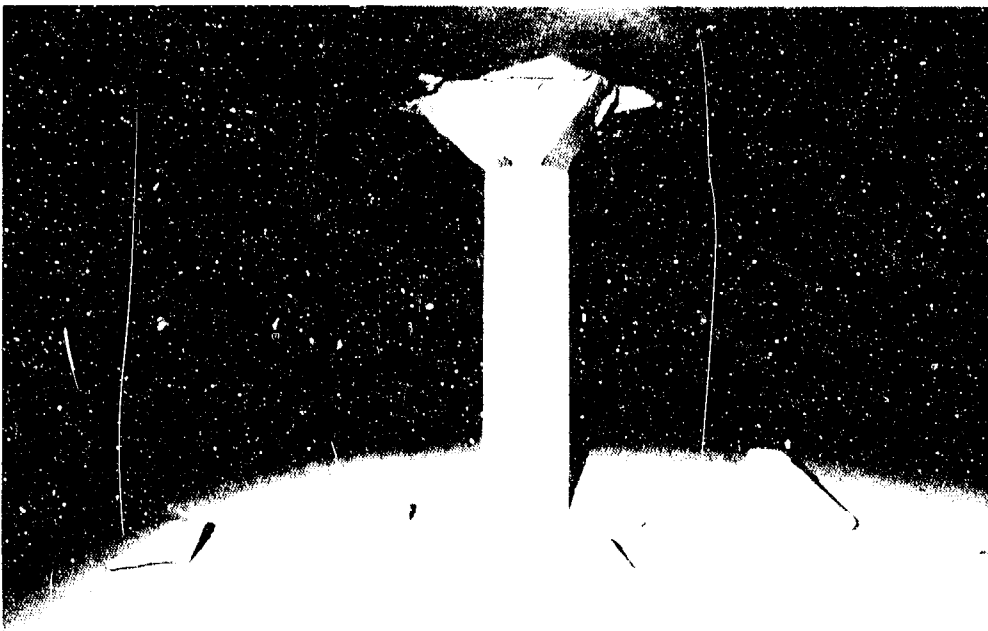
Figure 31. Post-test interior view of Type IIB test structure.

Observed Structural Response. Test IIB-DOORS took place on 12 September 1985. The explosive source was designed to produce a maximum impulse of 382 psi-msec and peak overpressure of 50 psi on the centerline of the Type IIB magazine headwall. Generally, measurements of blast loading made during the test were slightly lower than the predicted levels. The measured impulse at the headwall centerline was 355 psi-msec with an initial peak overpressure of 58 psi. A comparison of the roof and headwall gage output for ESKIMO's VI and VII is quite similar. Figure 28 shows the magazine being engulfed by the fireball. A post-test view of the magazine and crater is shown in Figure 29. Crater dimensions were 9-foot depth and 20-foot radius. The redesigned door and headwall system remained intact and more than satisfied the explosives safety deficiencies uncovered in ESKIMO VI. Buckling of the exterior steel face plate of the near door is illustrated in Figure 30. Maximum permanent door deflections of the near and far doors were measured as 9/16 inch and 3/16 inch, respectively. The only significant magazine damage observed was to the capital of the near column. Several large concrete pieces had separated as shown in Figure 31.

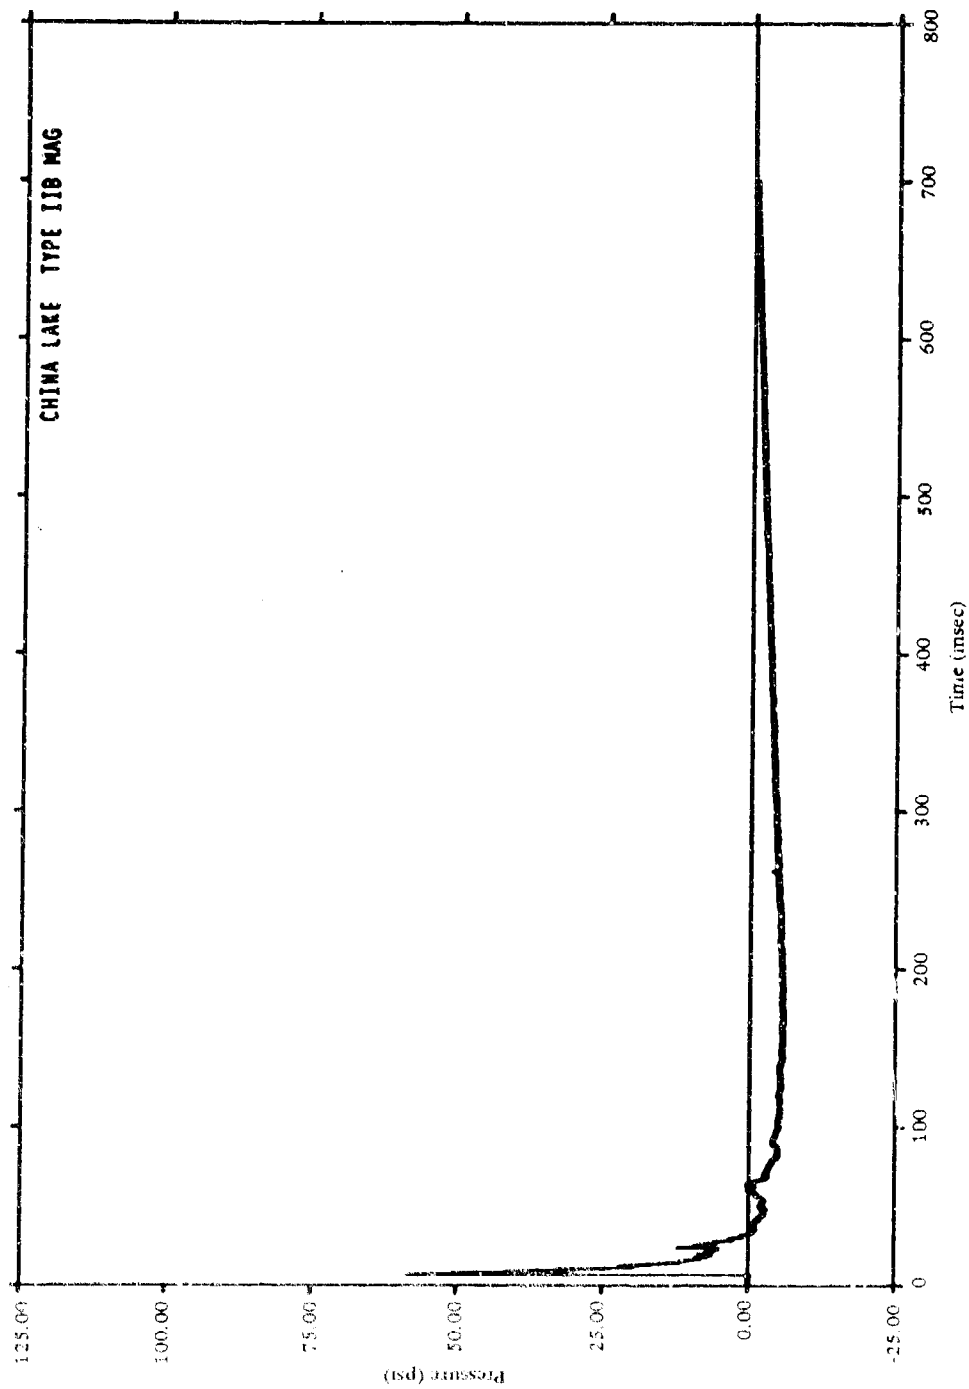
Figure 32. Typical airblast gage output for Test IIB-DOORS, Gage No. B-CID-BP4; headwall centerline.

Response Instrumentation. Data recovery in general was good. A summary of the pressure gage output is listed in Tables 8 and 9 and a representative time history plot is shown in Figure 32. A comparison of the measured air-blast impulse versus the predicted (from Ref 9) is shown in Figure 33. A summary of data derived from the velocity gage output is listed in Table 10 and a representative time history plot is shown in Figure 34. Displacement was established by integration of the velocity gage output. Displacement transducers were strategically positioned so as to measure the maximum displacement of the headwall, pilasters, and doors. A summary of the displacement gage data is listed in Table 11 and a representative time history plot is shown in Figure 35. A summary of the strain gage output is listed in Table 12 and a representative time history plot is shown in Figure 36.

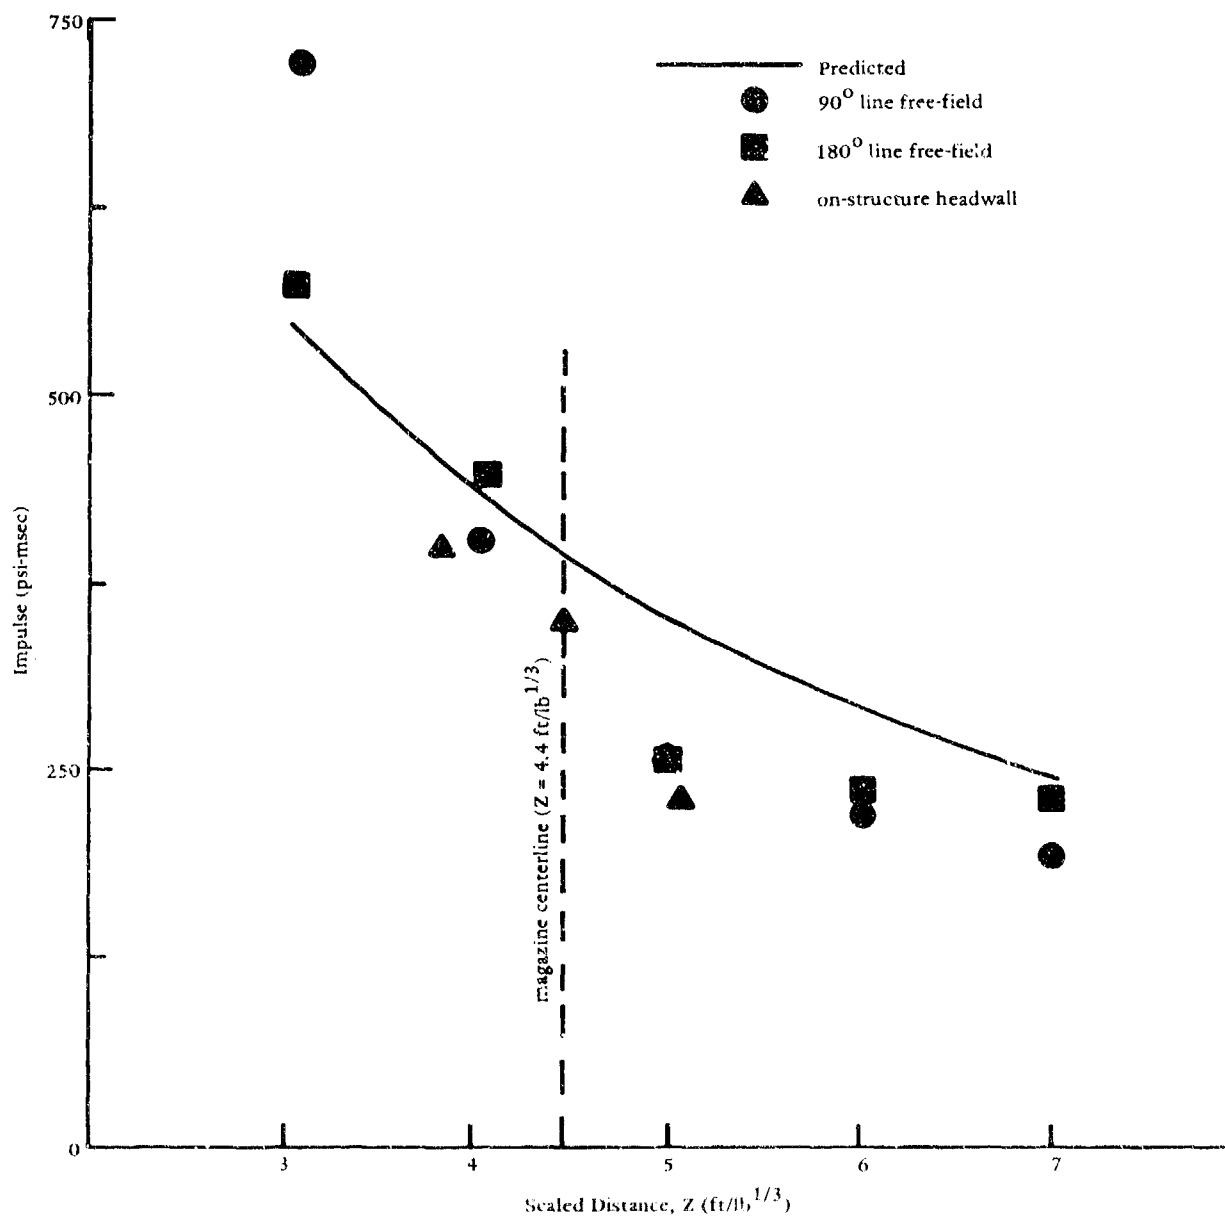
Figure 33. Measured versus predicted airblast loading for Test HIB-DOORS.

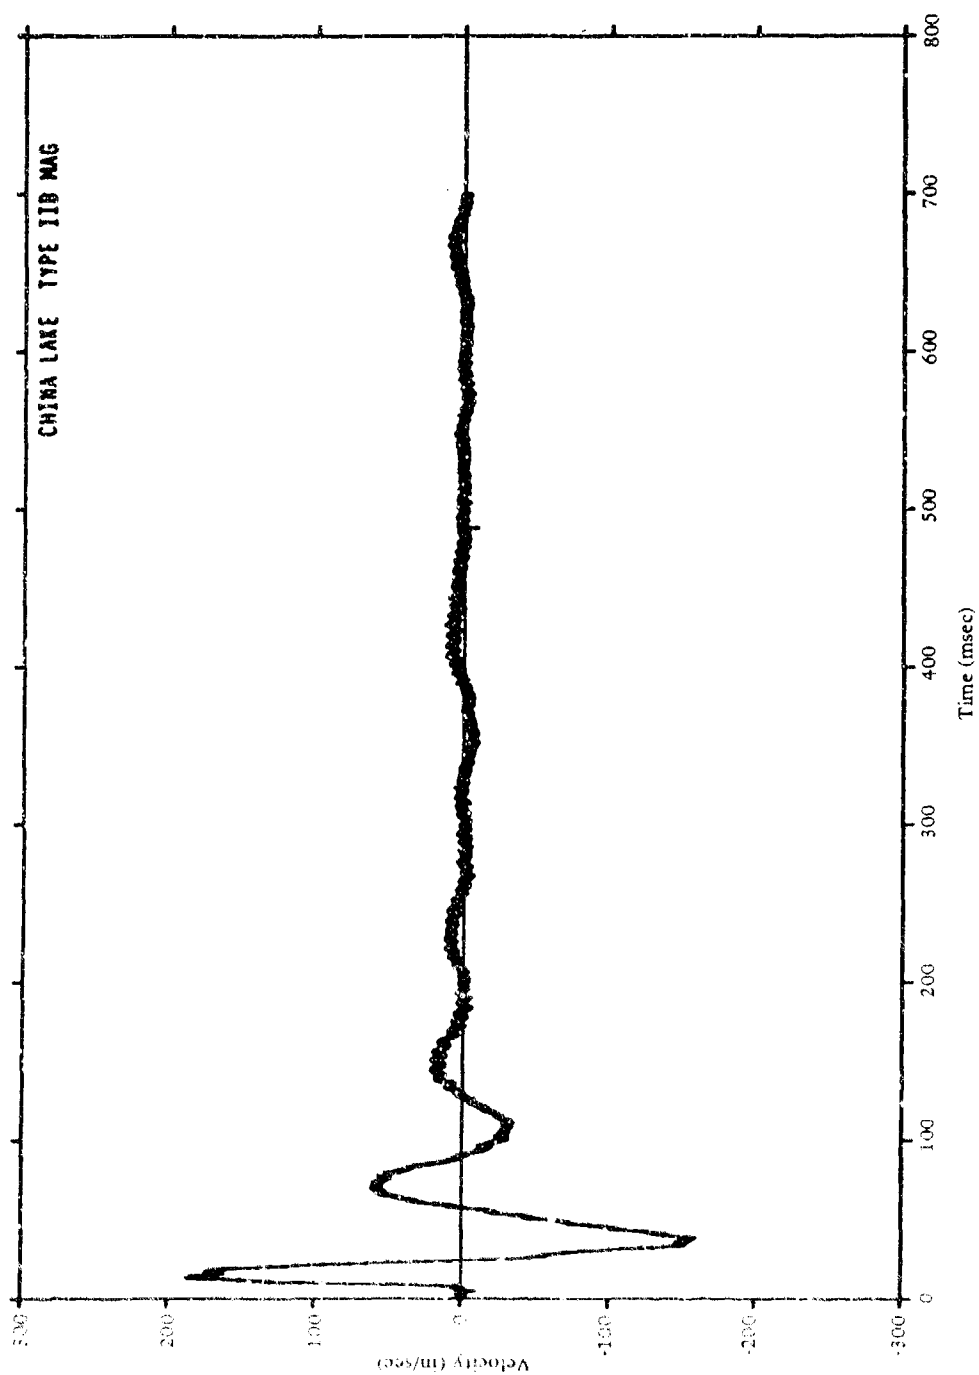
Figure 34. Typical velocity gage output for Test IIB-DOORS, Gage No. B-CID-V3:
headwall centerline.

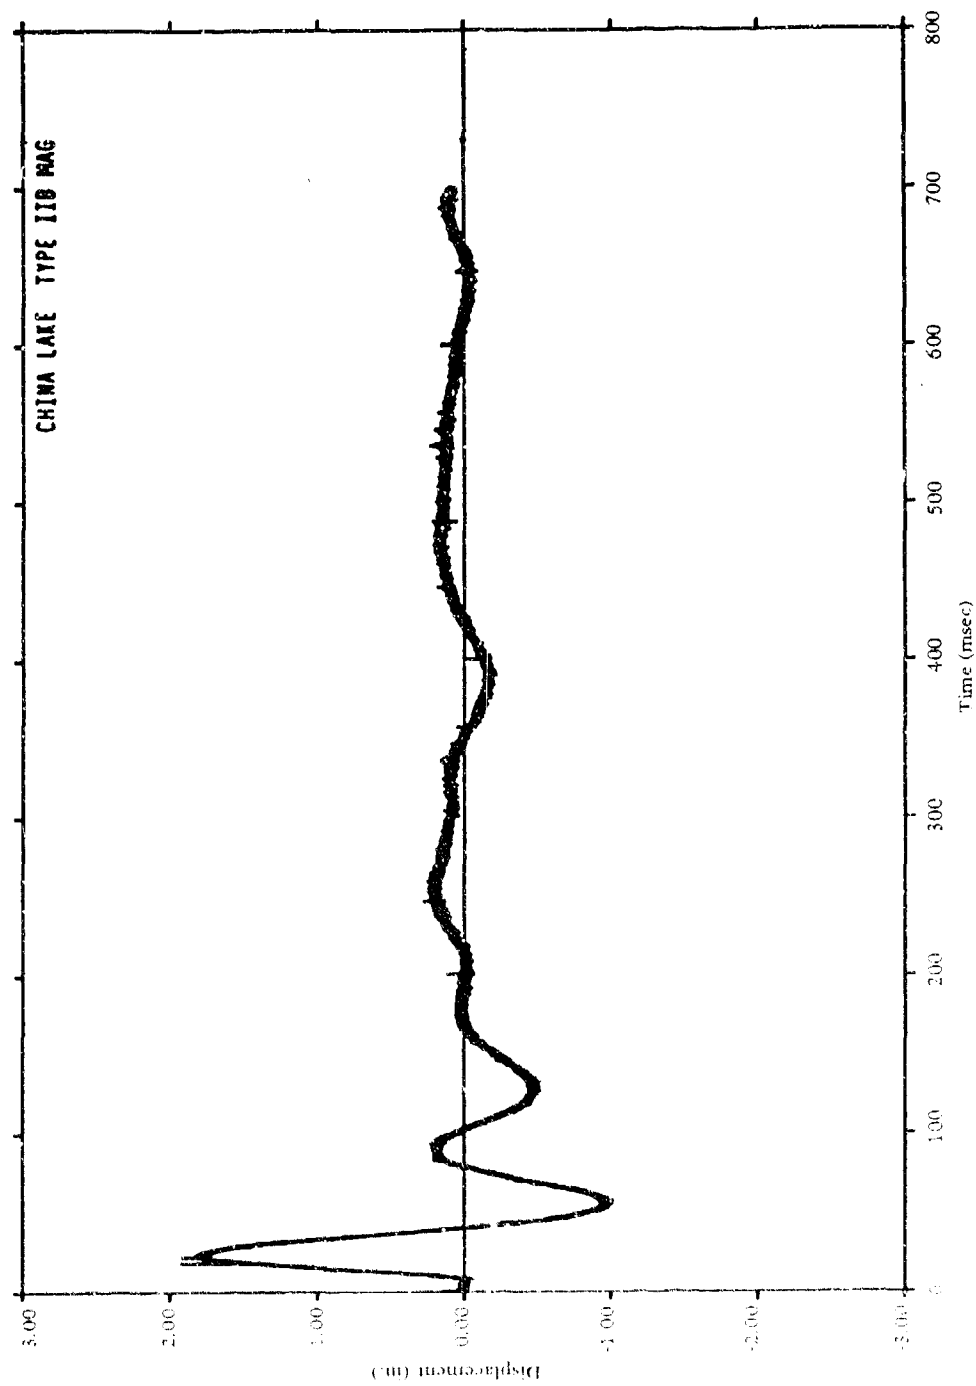
Figure 35. Typical displacement gage output for Test IIB-DOGRS, Gage No. B-CID-D5: headwall centerline.

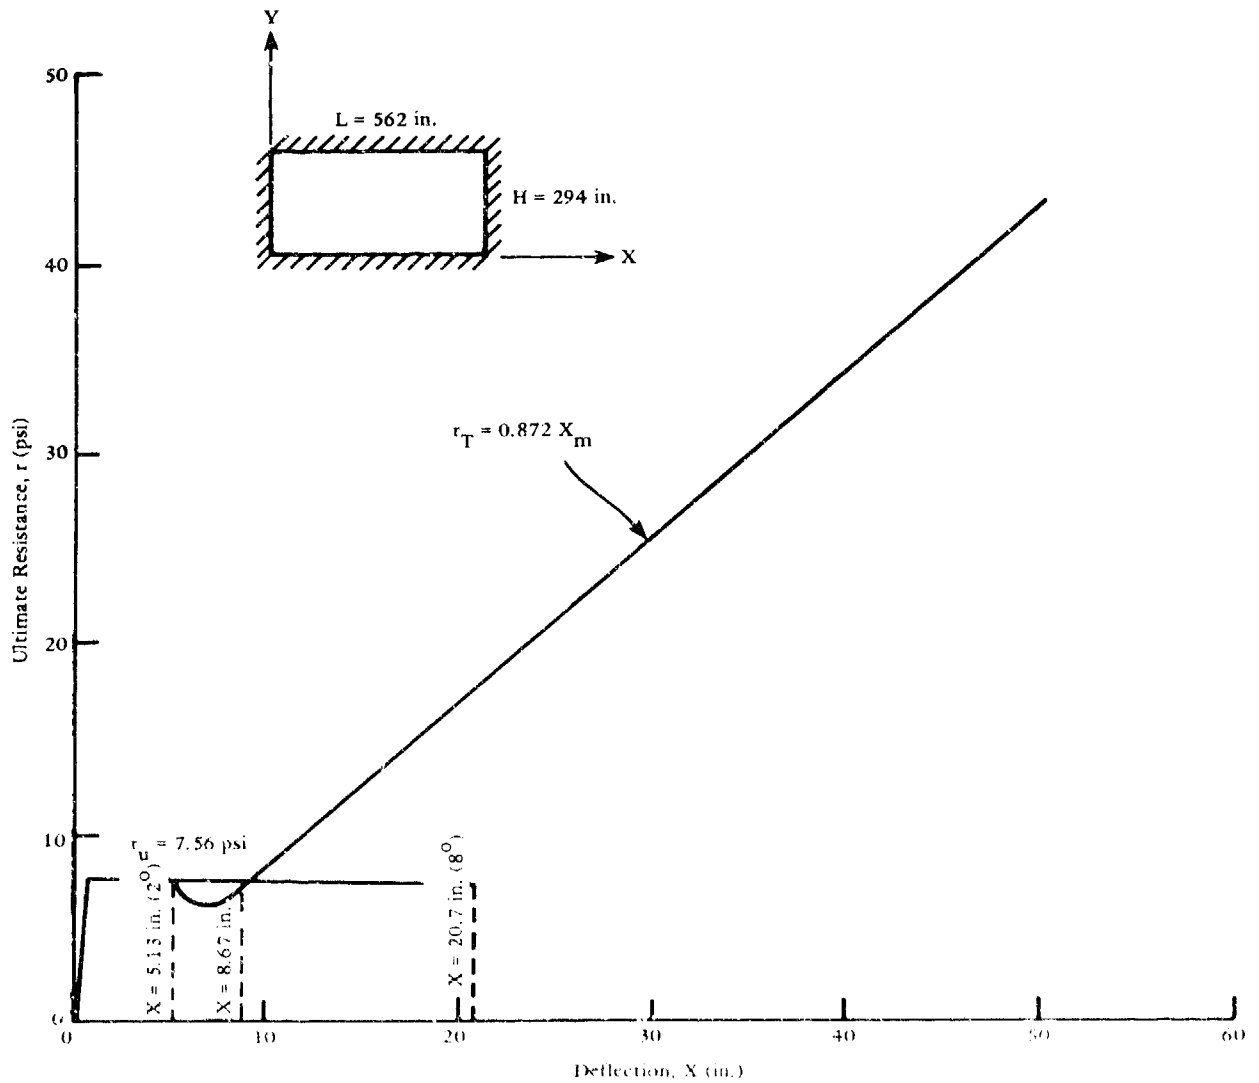
Figure 37. Available resistance deflection curve for half scale Type A magazine roof after column failure, two way restrained slab.

Although the intended purpose of the test was not achieved, significant findings in the areas of column design, slab deflection capacity, and tensile membrane behavior were uncovered. The loading capability of the HEST technique was awesome. A total of only 264 pounds NEW of primacord produced an impulse of 2,500 psi-msec on the magazine roof while in ESKIMO VI, 44,000 pounds NEW produced only 656 psi-msec impulse. Since the pressure pulse shapes from this HEST explosion and an HE magazine detonation are similar, the observed test results are considered appropriate. A post-test dynamic analysis of the column for the blast load acting directly on the column indicated column failure. The loaded area in this analysis was limited to the area of the drop panel. The current column design procedures (Ref 4) neglects this "early" loading condition and only considers a loading equal to the ultimate resistance of the roof acting over the tributary area supported by the column. Under most loading conditions, the direct blast loading would not control the column design. However, as demonstrated in ESKIMO VII, it is possible that for a high magnitude blast load acting on a relatively low resistance roof, the column could fail before the flat slab yield line patterns could develop and thus the direct blast loading would control. The column failures immediately transformed the roof slab into a rectangular two-way slab restrained on four sides with an aspect ratio L/H of 1.9. In order for this roof slab to develop tension membrane behavior, adequate lateral restraint of the reinforcement is mandatory. However, external lateral restraint is not required for elements supported on four edges provided the aspect ratio is not less than one-half nor greater than two. Within this range, the inherent lateral restraint provided by the element's own compression ring around its boundary is sufficient lateral restraint to develop tension membrane behavior. The Type A magazine roof satisfies both restraint conditions and thus, tensile membrane behavior is possible. The tensile membrane resistance function for the Type A magazine roof is shown in Figure 37. A dynamic response calculation using this function and the measured roof loading resulted in a predicted maximum displacement of 49.7 inches. This is only slightly greater than the measured post-test permanent displacement of 45.5 inches. Even though no stirrups were used, the concrete on the underside of the roof remained intact except for small regions of the column bands where the bottom steel was cut off.
